TWR-17543 Vol. IV

Flight Set 360T004 (STS-30)  
Seals Final Report

March 1990

Flight Set 360T004 (STS-30)  
SEALS FINAL REPORT  
Volume IV

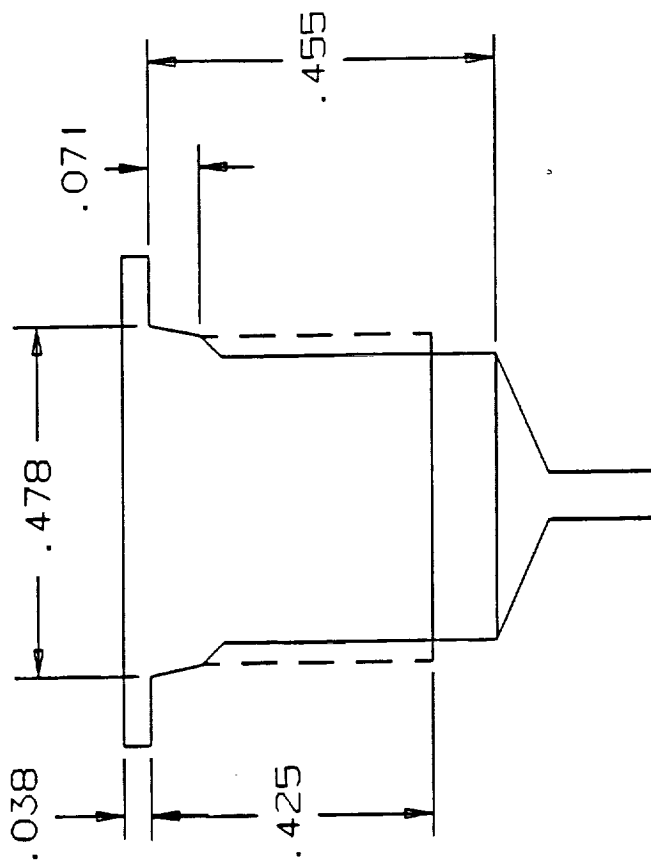
EXISTING CONDITIONS

Inspection of the barrier booster (B-B) rotor shaft housing bore revealed scratches that could be felt using a 5 and 10 mil piece of brass shim stock. The scratches were on the secondary sealing surface similar in footprint to three units previously found at ECC (the vendor). It was determined that these scratches were caused by the bore micrometer used to measure the bore diameters prior to assembly.

Scratches, found on 4th flight (360L004) Barrier-Booster housing bores, were not found prior to assembly.

- Units built after 4th flight could have unacceptable scratches.
